Volume II

Appendix D.7

Working Scenario

The Working Scenario was the result of a joint effort between the Columbia Accident Investigation Board (CAIB) and the NASA Accident Investigation Team (NAIT). The report was written beginning early in the investigation to track the current understanding of the events that led to the loss of *Columbia*. As such, the report evolved over time as facts became known, theories were developed or disproved, and NASA and the Board gained knowledge of the accident sequence.

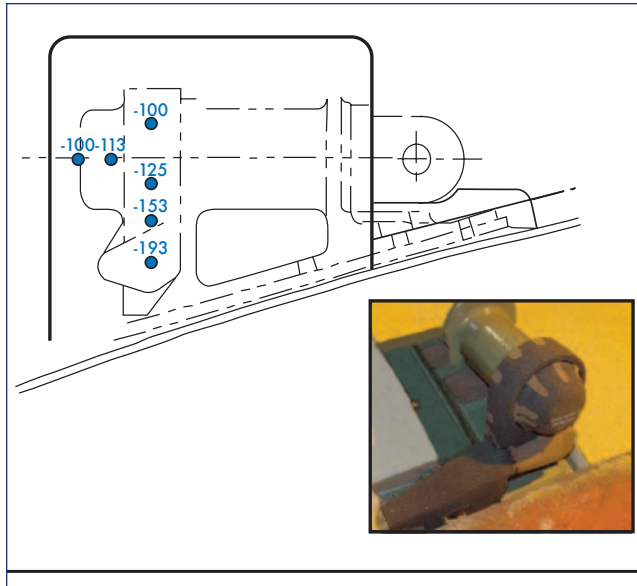
Figure 11-10. Max bipod SLA temperatures (80 seconds MET), °F.

The maximum SLA temperatures possible at 80 seconds were analyzed to determine maximum worst-case multi-event material loss. No cryopumping or cryo ingestion was assumed in order to calculate temperatures as high as possible. STS-107 ambient environments were used. Results showed the maximum SLA temperature possible at 80 seconds MET is less than or equal to -100°F , as shown in Figure 11-10. Tension testing shows BX-250 fails before SLA at temperatures less than or equal to -100°F .

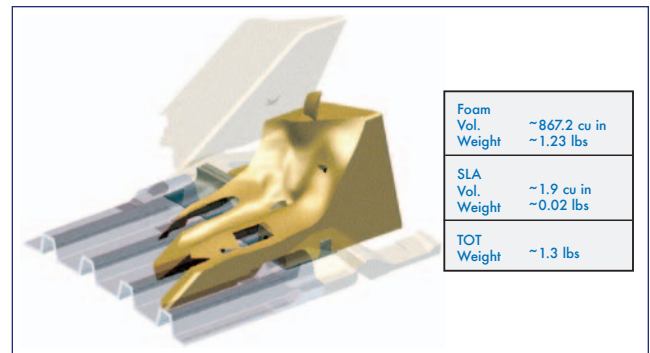
The ET Working Group conducted an analysis coupled with test data to estimate a multi-failure mode TPS bipod debris size and weight. The ET Working Group scenario includes seven simultaneous and interactive adverse events: A large rollover occurs at the inboard stringer interface immediately below the machined foam surface, side-to-side thermal crack/weak knit line, a large void near the topmost surface one inch below machined foam surface, warm SLA environment, and foam machined to minimum tolerances (not a failure). The specific results are shown in Figure 11-13.

Figure 11-13. Multi-failure mode bipod TPS debris estimated by the ET Working Group. Note that this size and weight were not used in the RCC impact testing as part of the STS-107 investigation.

The determination of the STS-107/ET-93 bipod TPS debris is based on evaluation of fault tree findings, possible TPS failure modes and contributors, and results to date from TPS debris test programs including dissection, foam loss secondary effects assessment (SLA/BX-250), and bipod TPS debris size analysis. The TPS bipod debris size was determined by the ET Working Group to be approximately 870 cubic inches and 1.3 pounds.
